Flight Motor Set 360H005 (STS-28R) Final Report

**Volume V
(Nozzle Component)**

September 1990

***Thiokol* CORPORATION
SPACE OPERATIONS**

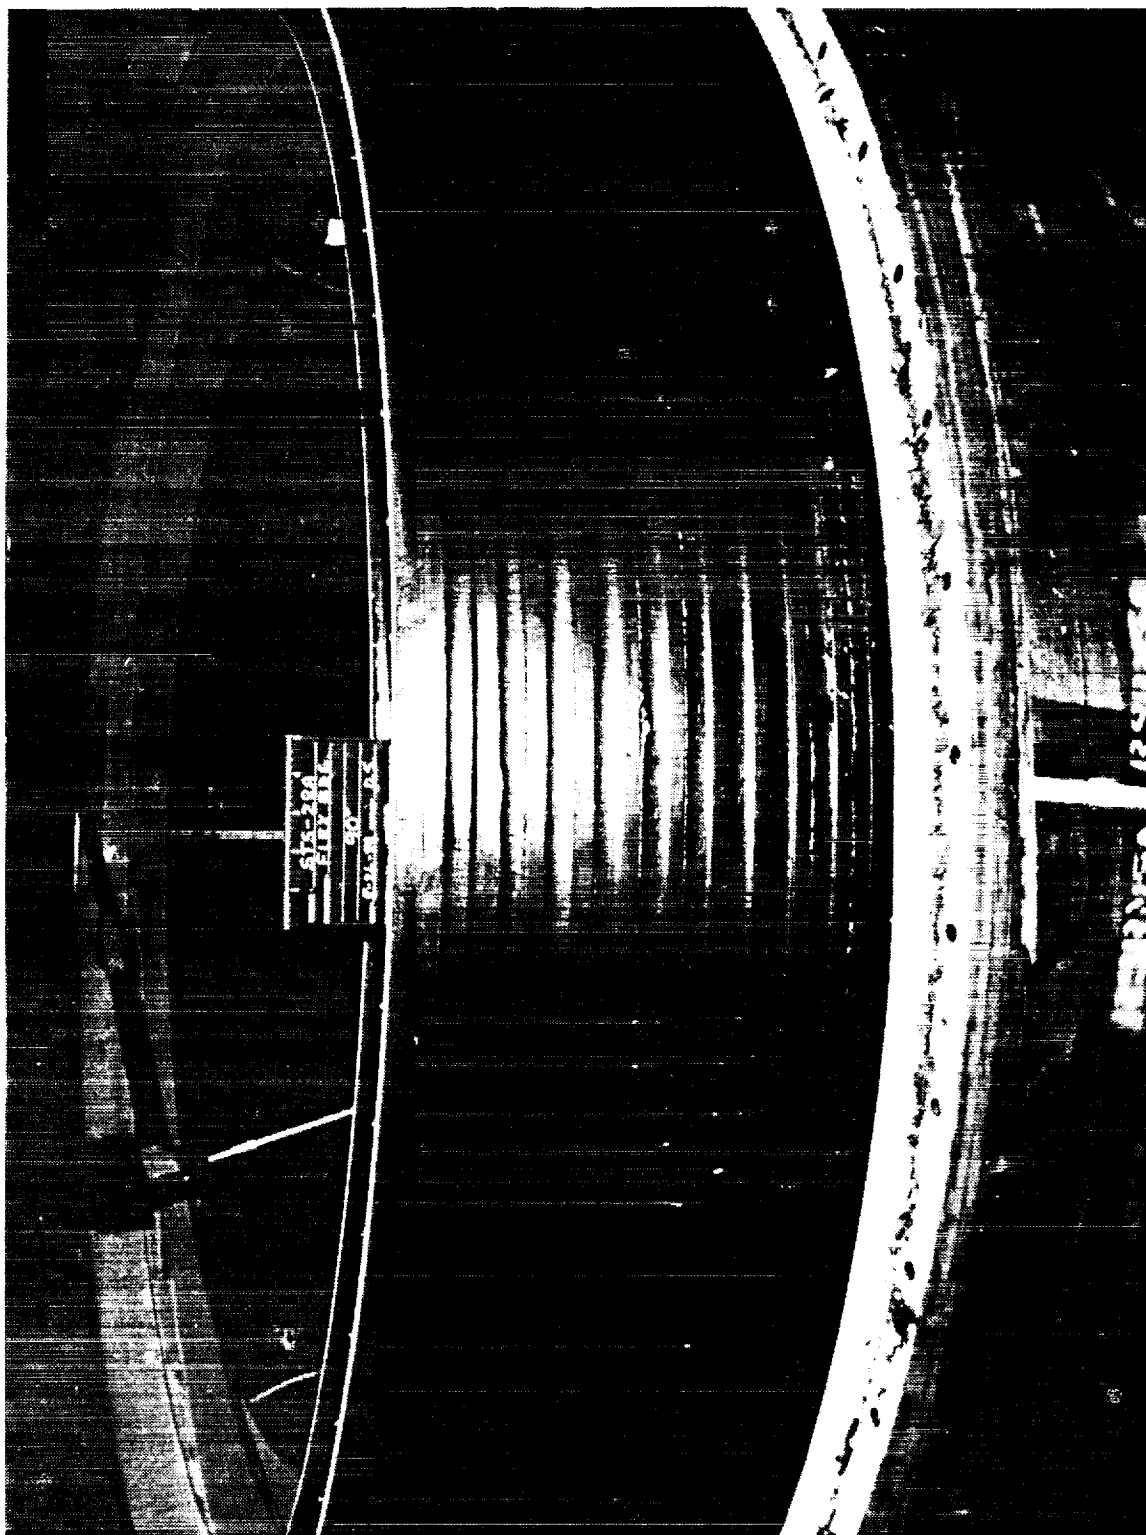
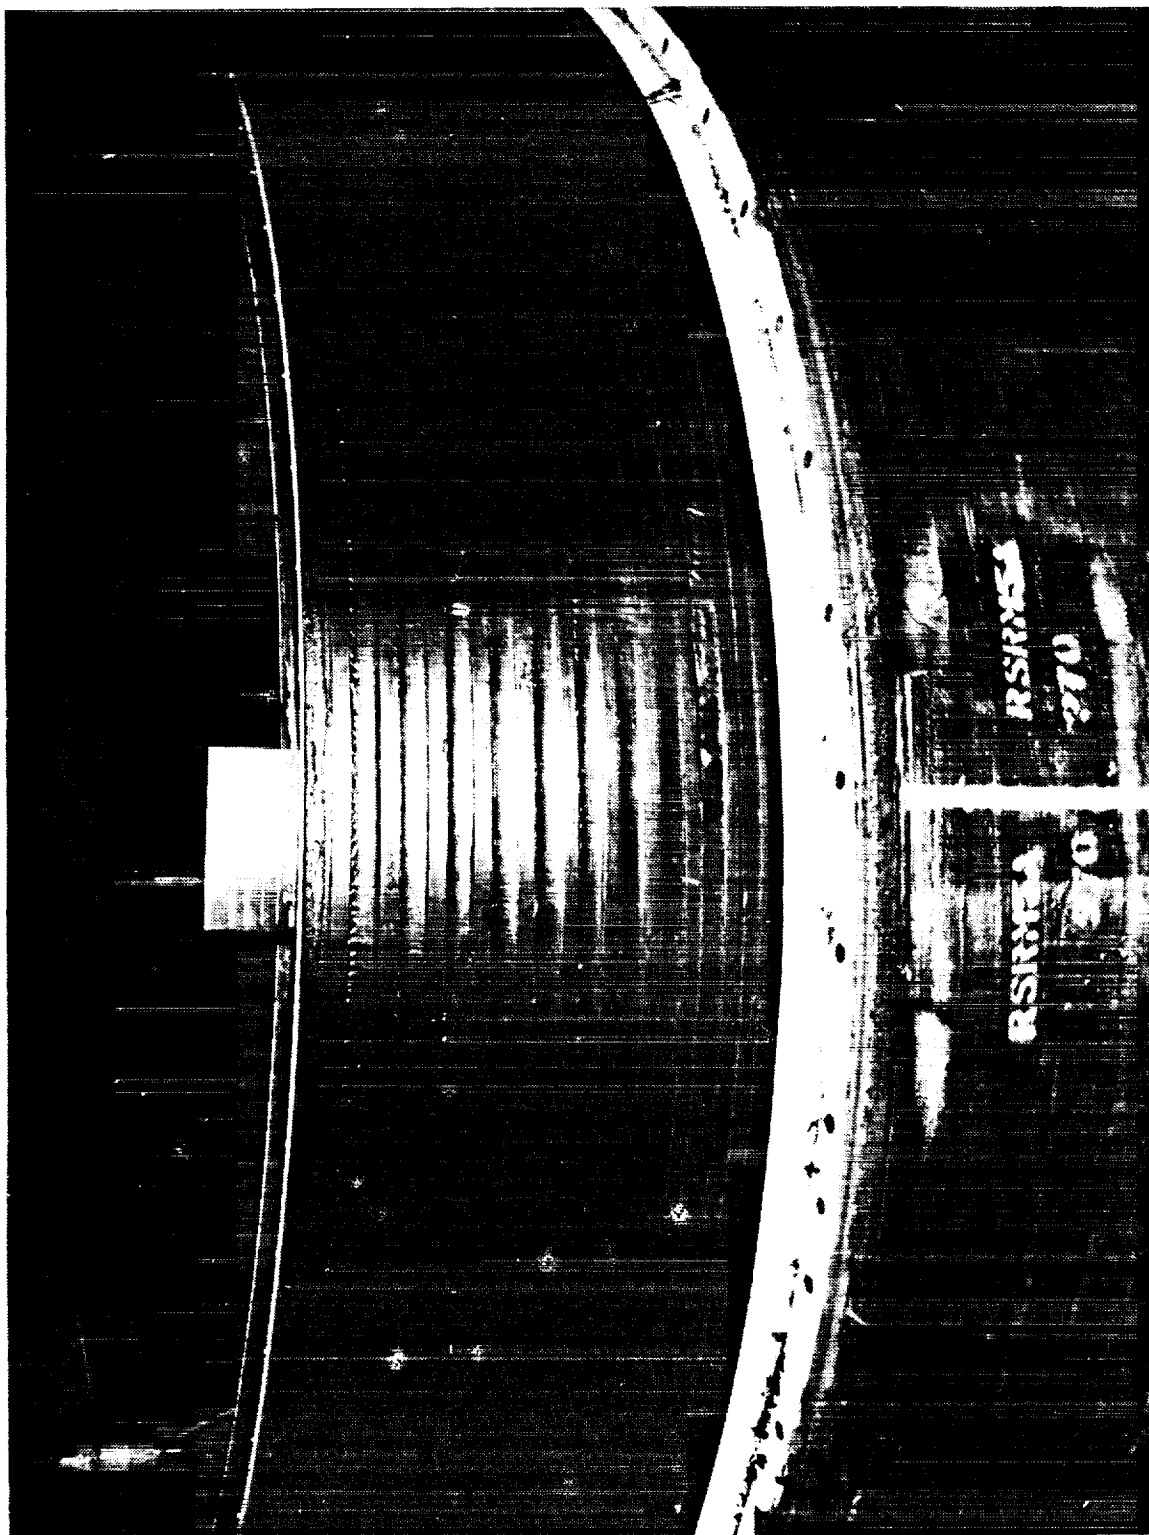
Examination of the flex bearing revealed no damage, soot, heat effect, or flow indications (see Figures 54 and 55). All rubber pads, metal shims, and end rings appeared to be in nominal condition. Subsequent refurbishment and testing has verified that the flex bearing is acceptable for reuse.

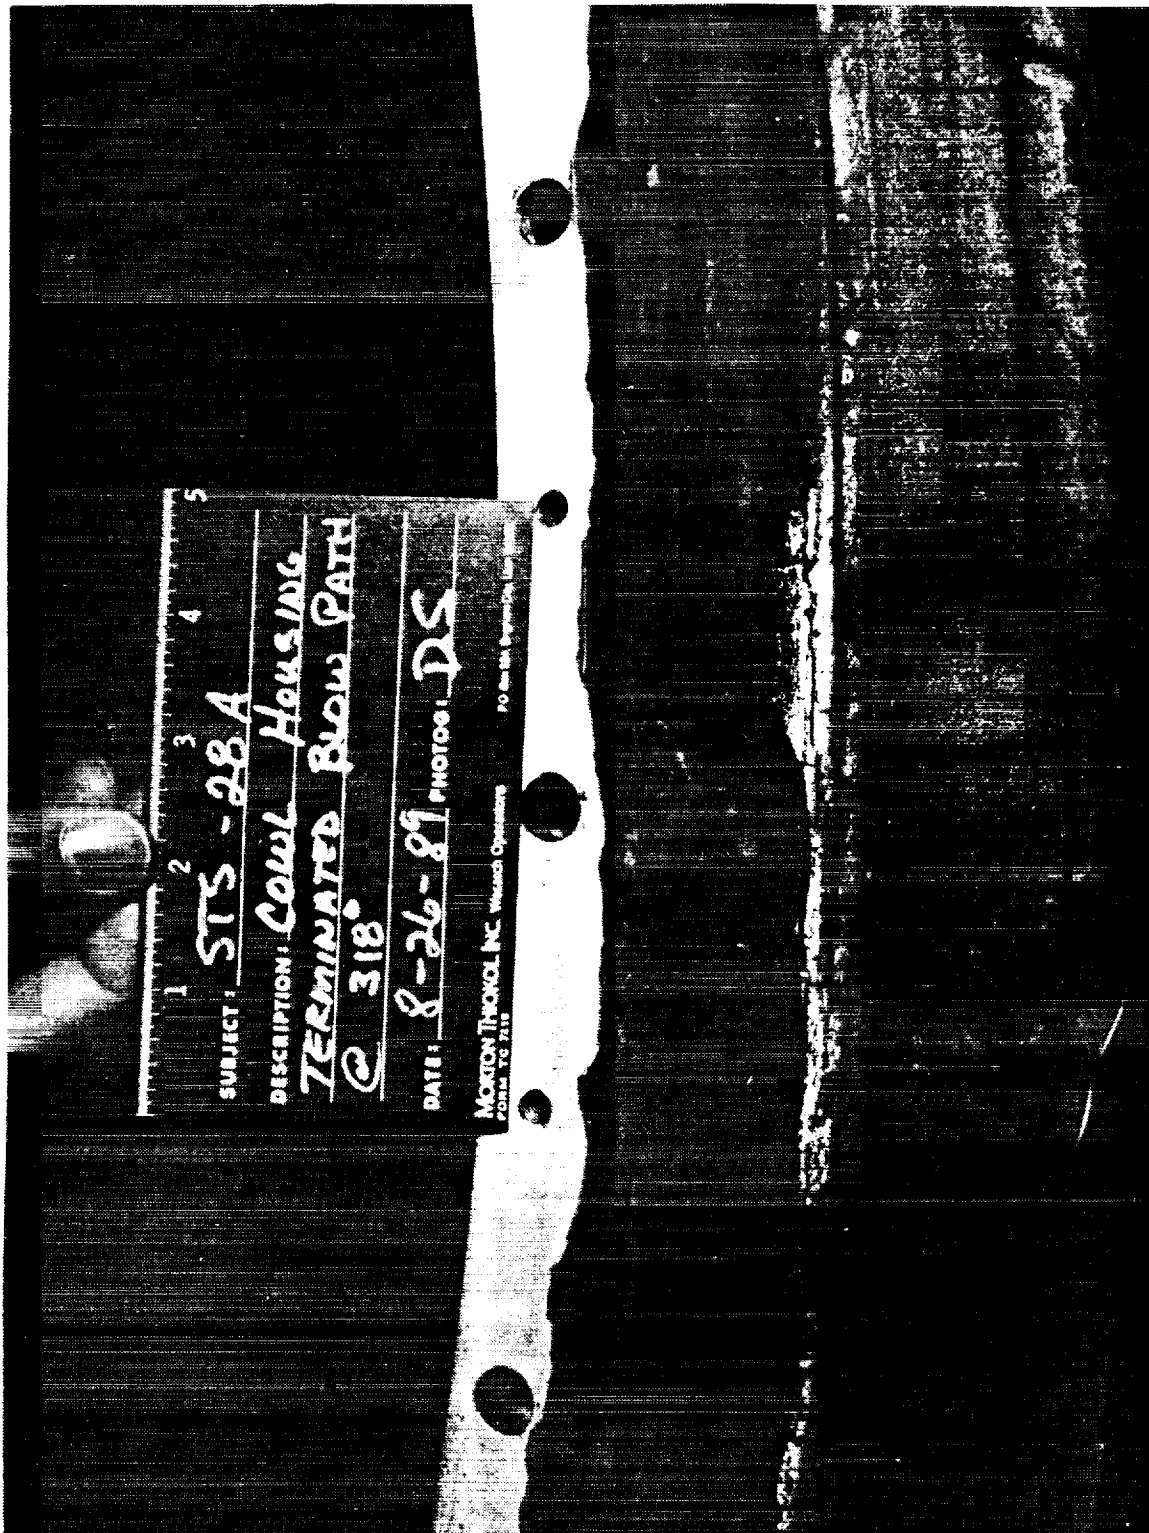
Figure 88 STS-28A Cowl Forward End - Blowpath Location (318 deg)

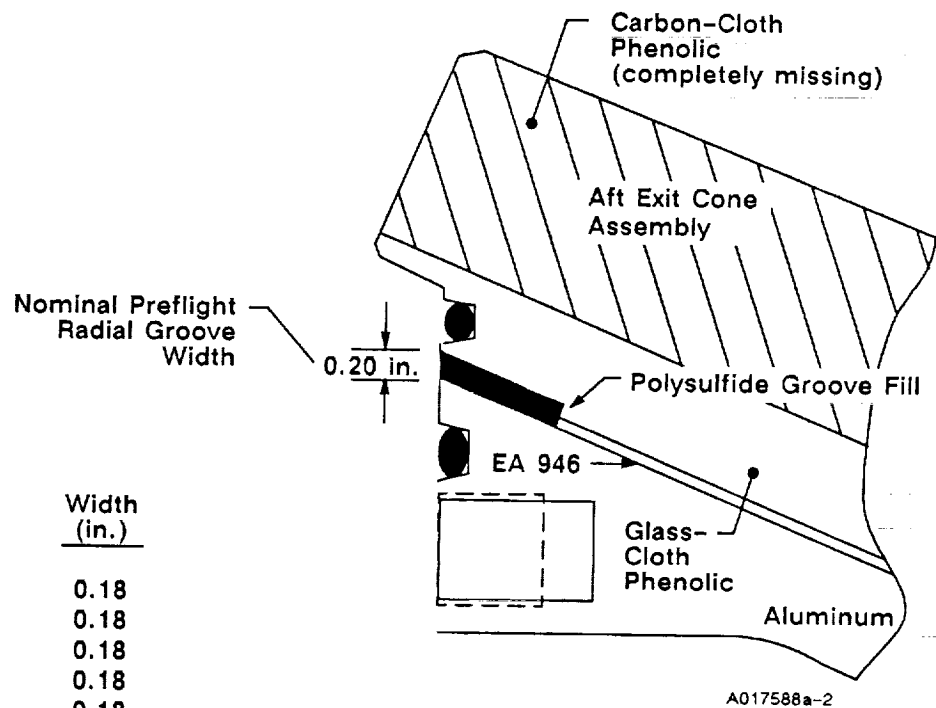
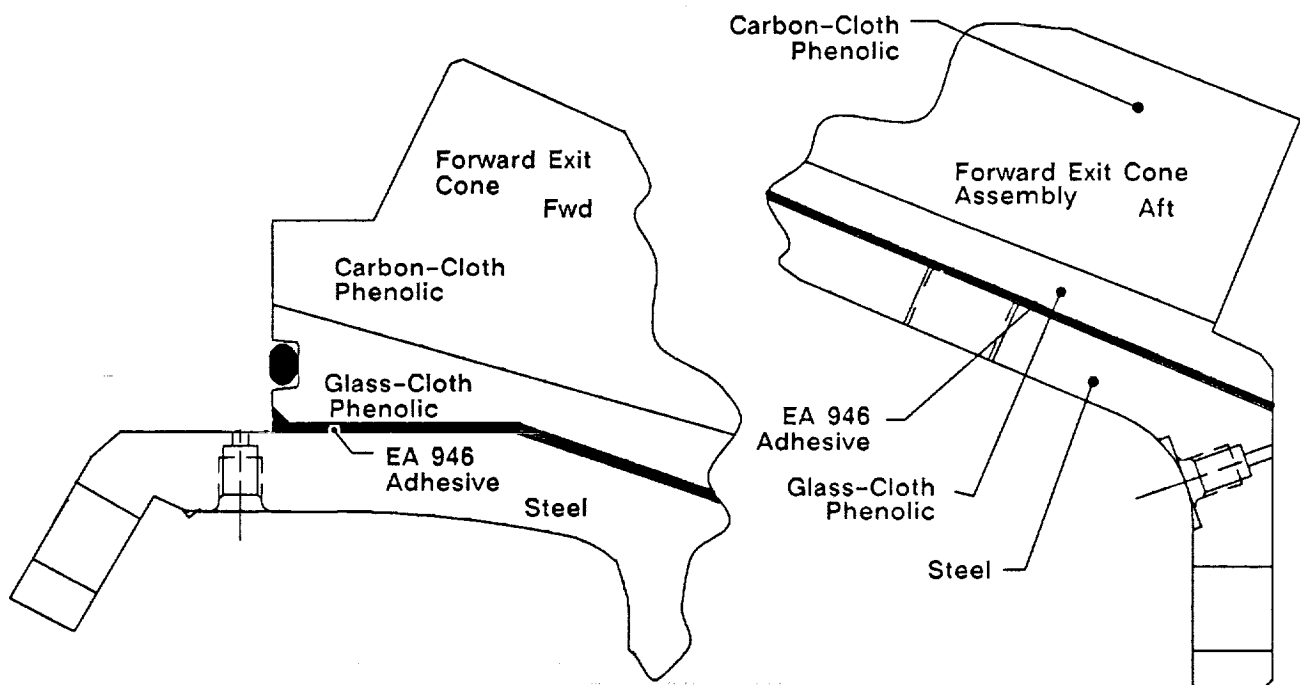
Figure 102 STS-28B Forward Exit Cone Bondline Separations

The aft end of the forward exit cone showed bondline separations between the EA946 adhesive and steel housing intermittently around the circumference. The maximum radial width of the separations was 0.02 inch. Bondline separations on the forward end of the forward exit cone were noted between the steel shell and the EA946 adhesive 360 degrees circumferentially. Figure 102 lists the location and radial width measurements of all separations on the forward exit cone. These are typical observations which occur postburn.

Forward End	
Metal-to-Adhesive Bondline Separations	
Location (deg)	Radial Separation (in.)
360	0.020
Circumferentially

Aft End	
Metal-to-Adhesive Bondline Separations	
Location (deg)	Radial Separation (in.)
0	0.020
30-45	0.010
60-75	0.020
105-135	0.010
150	0.020
285	0.010
300	0.020
330	0.005

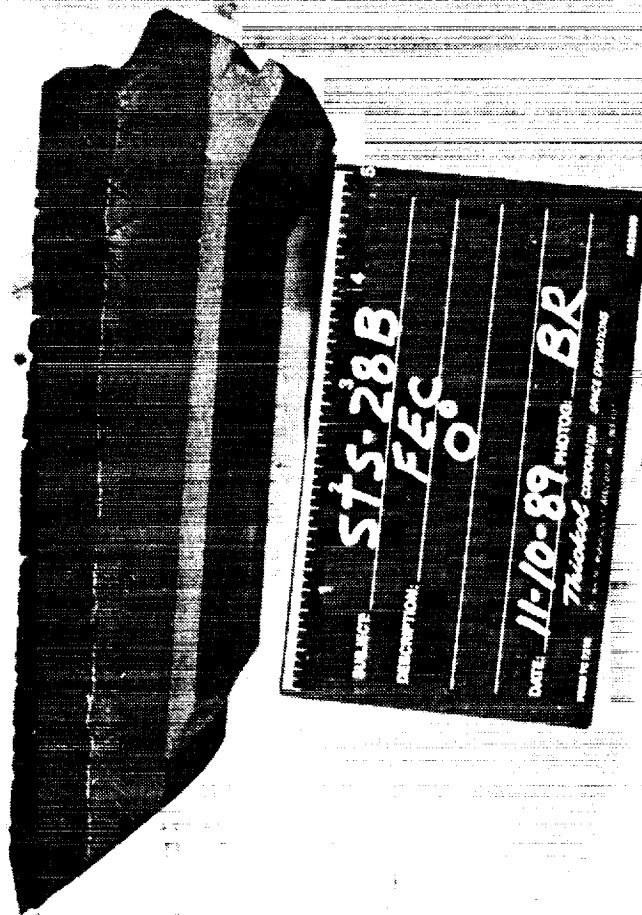
Figure 103 STS-28B Forward Exit Cone Liner Section (0 deg)

Photographs of the sectioned forward exit cone liner are presented in Figures 103 through 105. Char and erosion analysis of the sections is presented in Table 10. All margins of safety were positive, with a minimum of 0.04 occurring at station 28 (90 degrees).

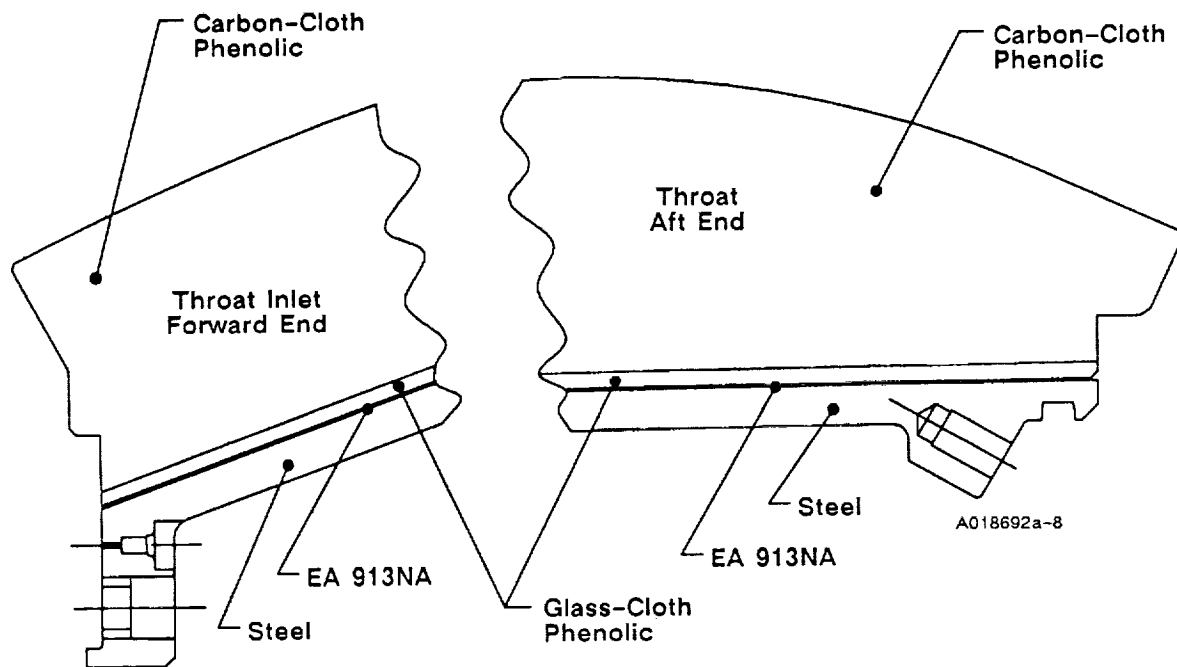
Figure 106 STS-28B Throat Assembly Bondline Separations

Bondline separations on the aft end of the throat ring between the EA913 NA adhesive and the steel throat support housing were observed 360 degrees circumferentially with a radial separation of 0.035 inch. The forward end of the throat inlet ring showed metal-to-adhesive bondline separations at 0-to-105, 120-to-210, and 225-to-345 degrees, with 0.02 inch maximum radial separation. Figure 106 lists the location and radial width of the measurements. These separations are typical observations seen on previous test and flight nozzles and occur postburn.

Fwd End Metal-to-Adhesive Bondline Separations	
Location (deg)	Radial Separations (in.)
0-105	0.020
120-210	0.010
225-345	0.020

Aft End Metal-to-Adhesive Bondline Separations	
Location (deg)	Radial Separation (in.)
360 Circumferentially	0.035

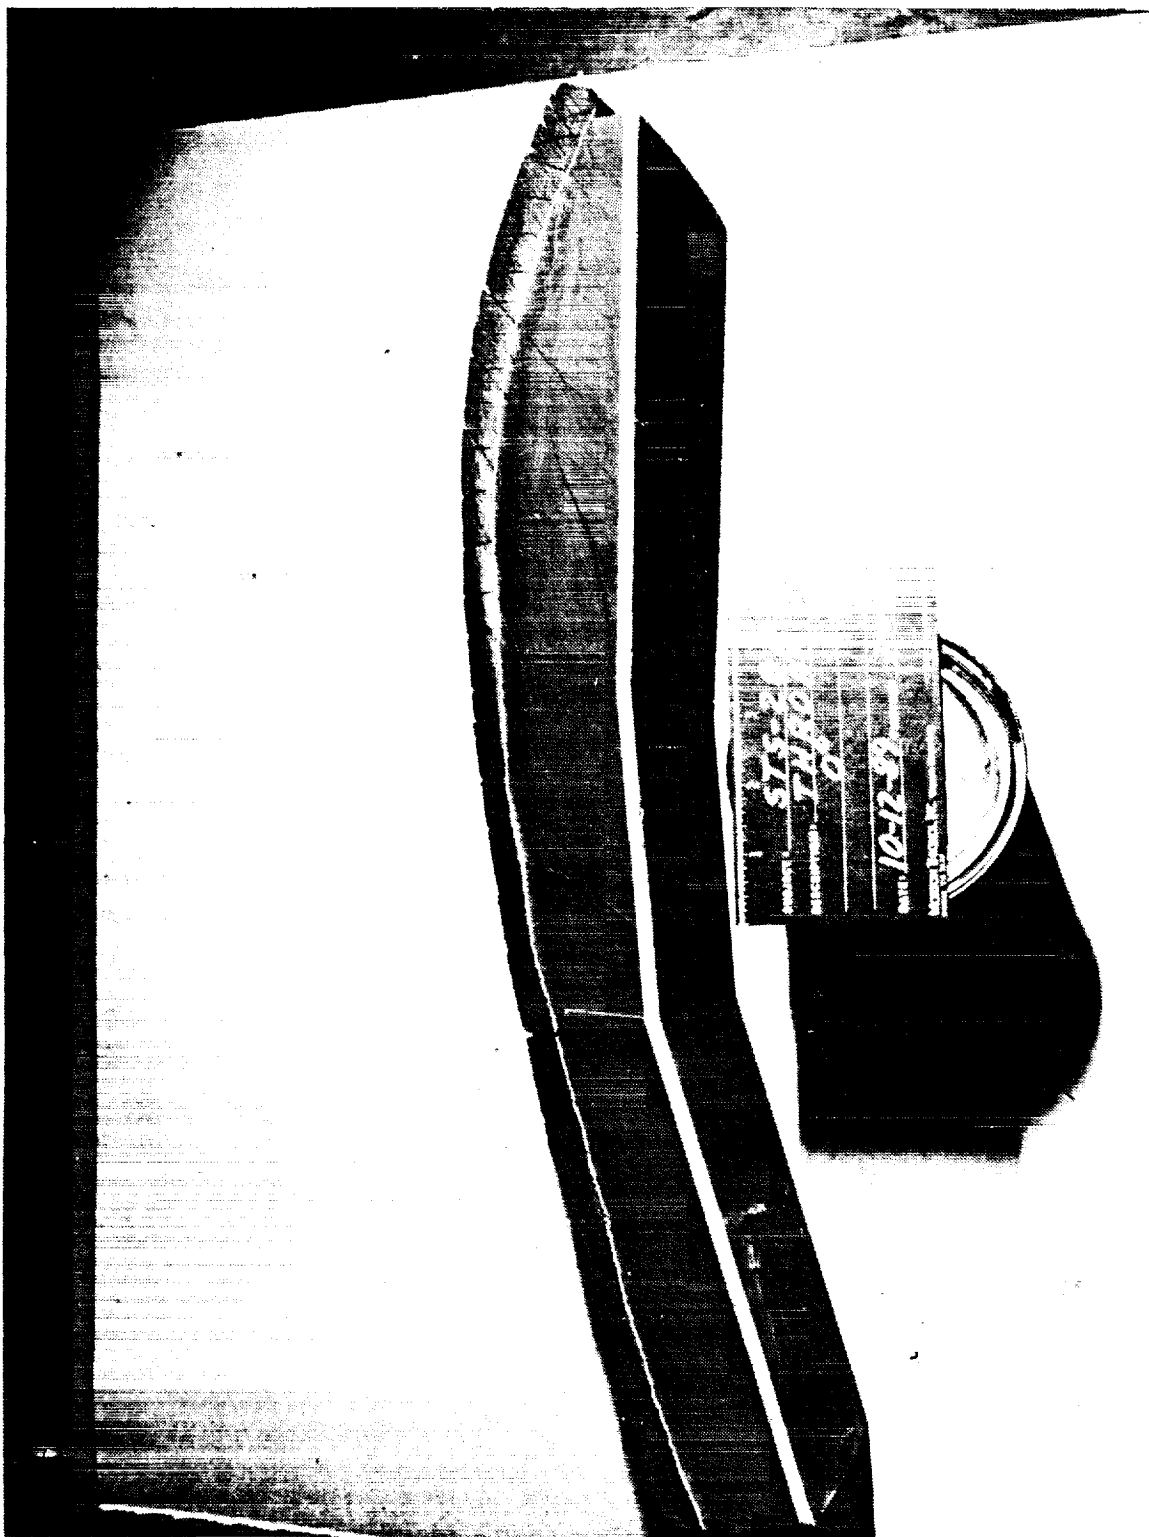
Figure 107 STS-28B Throat/Throat Inlet Section (0 deg)

Photographs of the sectioned throat assembly liner are presented in Figures 107 through 110. Char and erosion analysis of the sections is presented in Table 11. All margins of safety were positive, with a minimum of 0.05 occurring at station 8 (90 and 180 degrees).

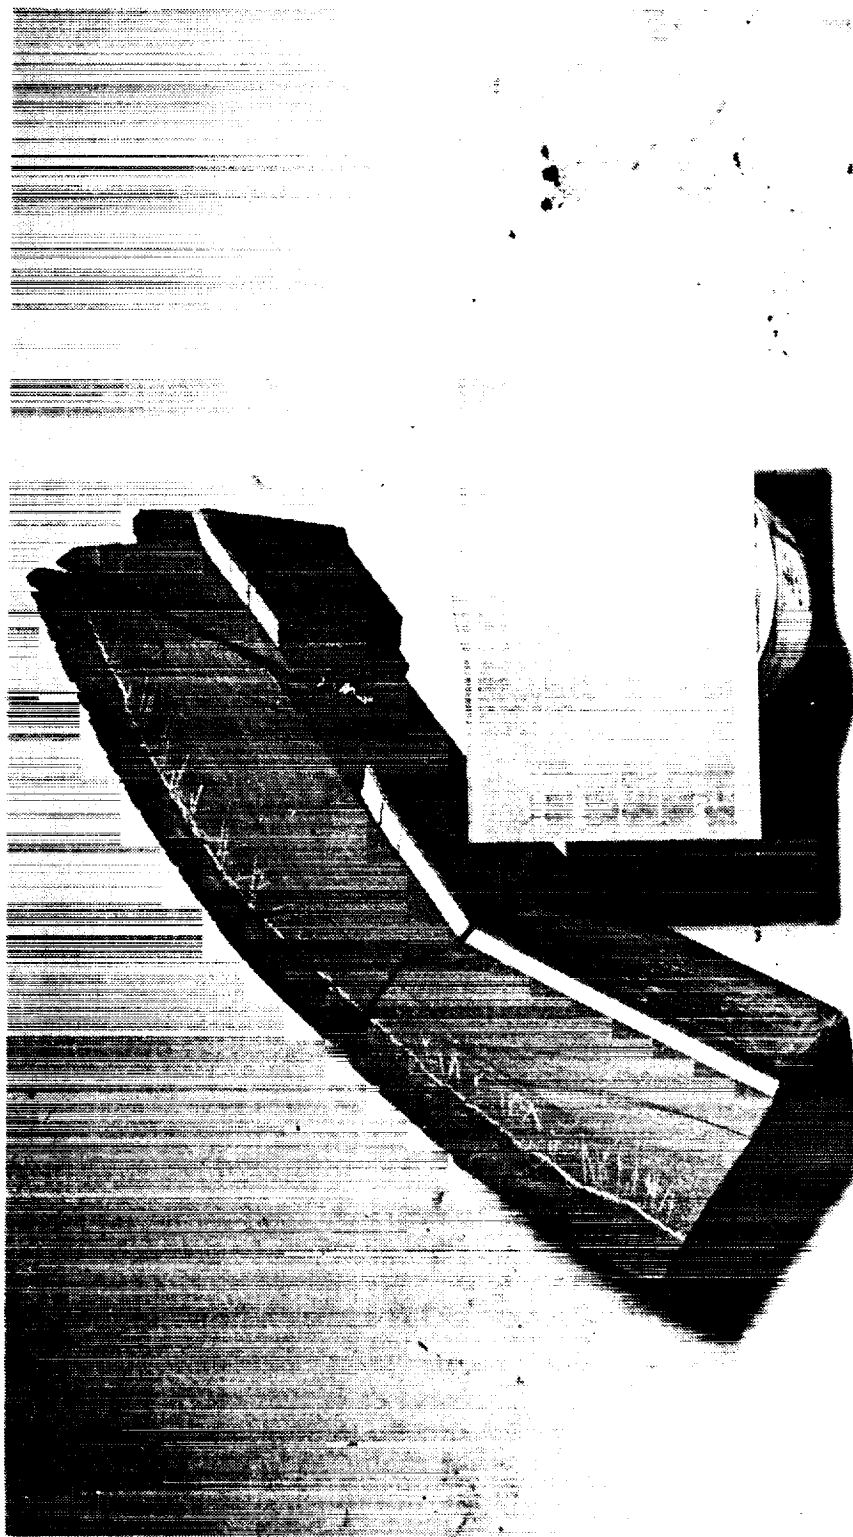
Figure 112 STS-28B Forward Nose Ring and Aft Inlet Ring (-503 and -504) Section (0 deg)

Photographs of the sectioned nose inlet assembly rings are presented in Figures 112 through 119. Char and erosion analyses of the sections are presented in Tables 12 and 13. All margins of safety were positive, with a minimum of 0.19 occurring at station 39 (90 and 180 degrees) for the -503/-504 rings, and 0.04 occurring at station 24 (270 degrees) for the nose cap.

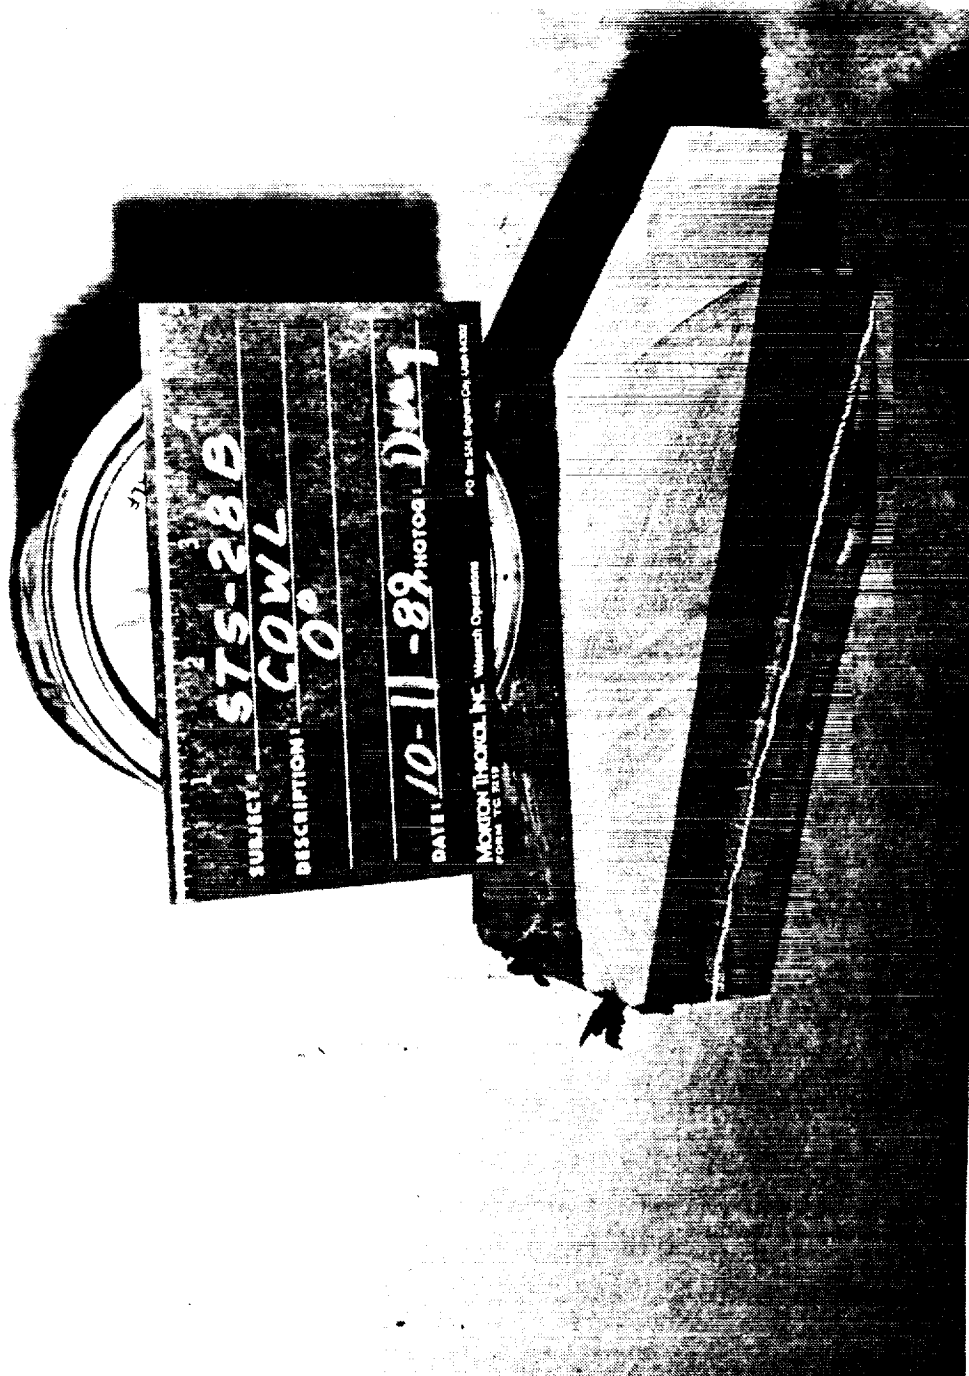
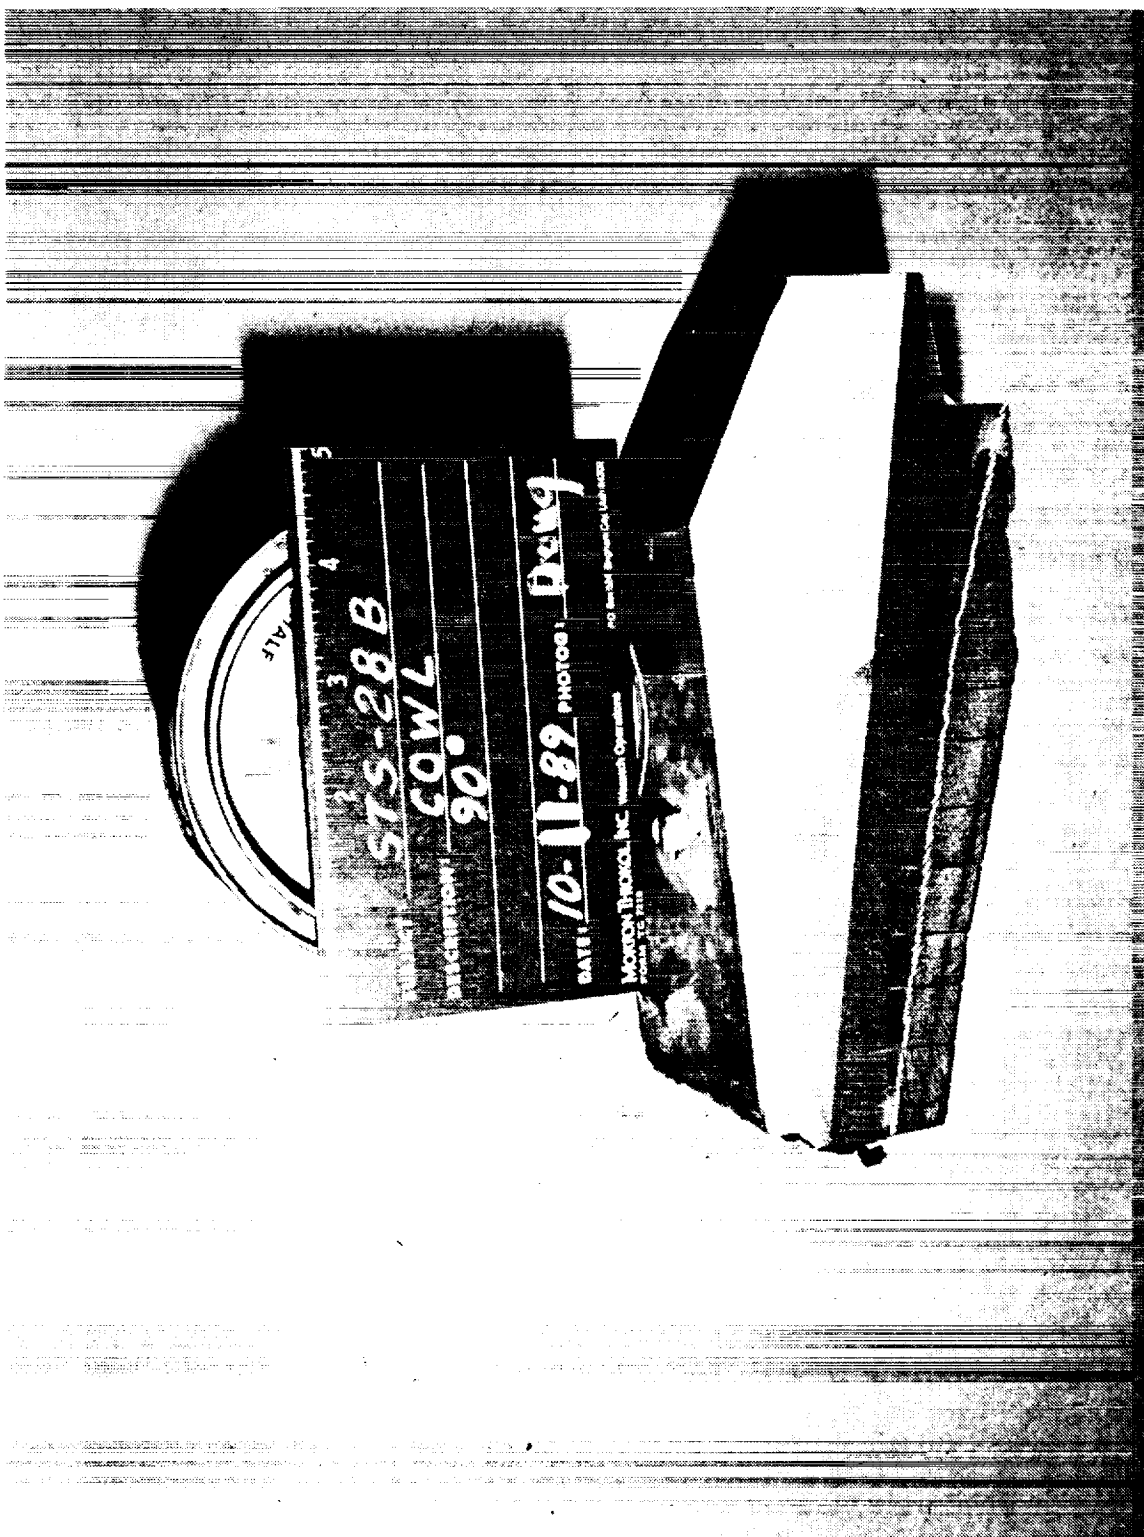
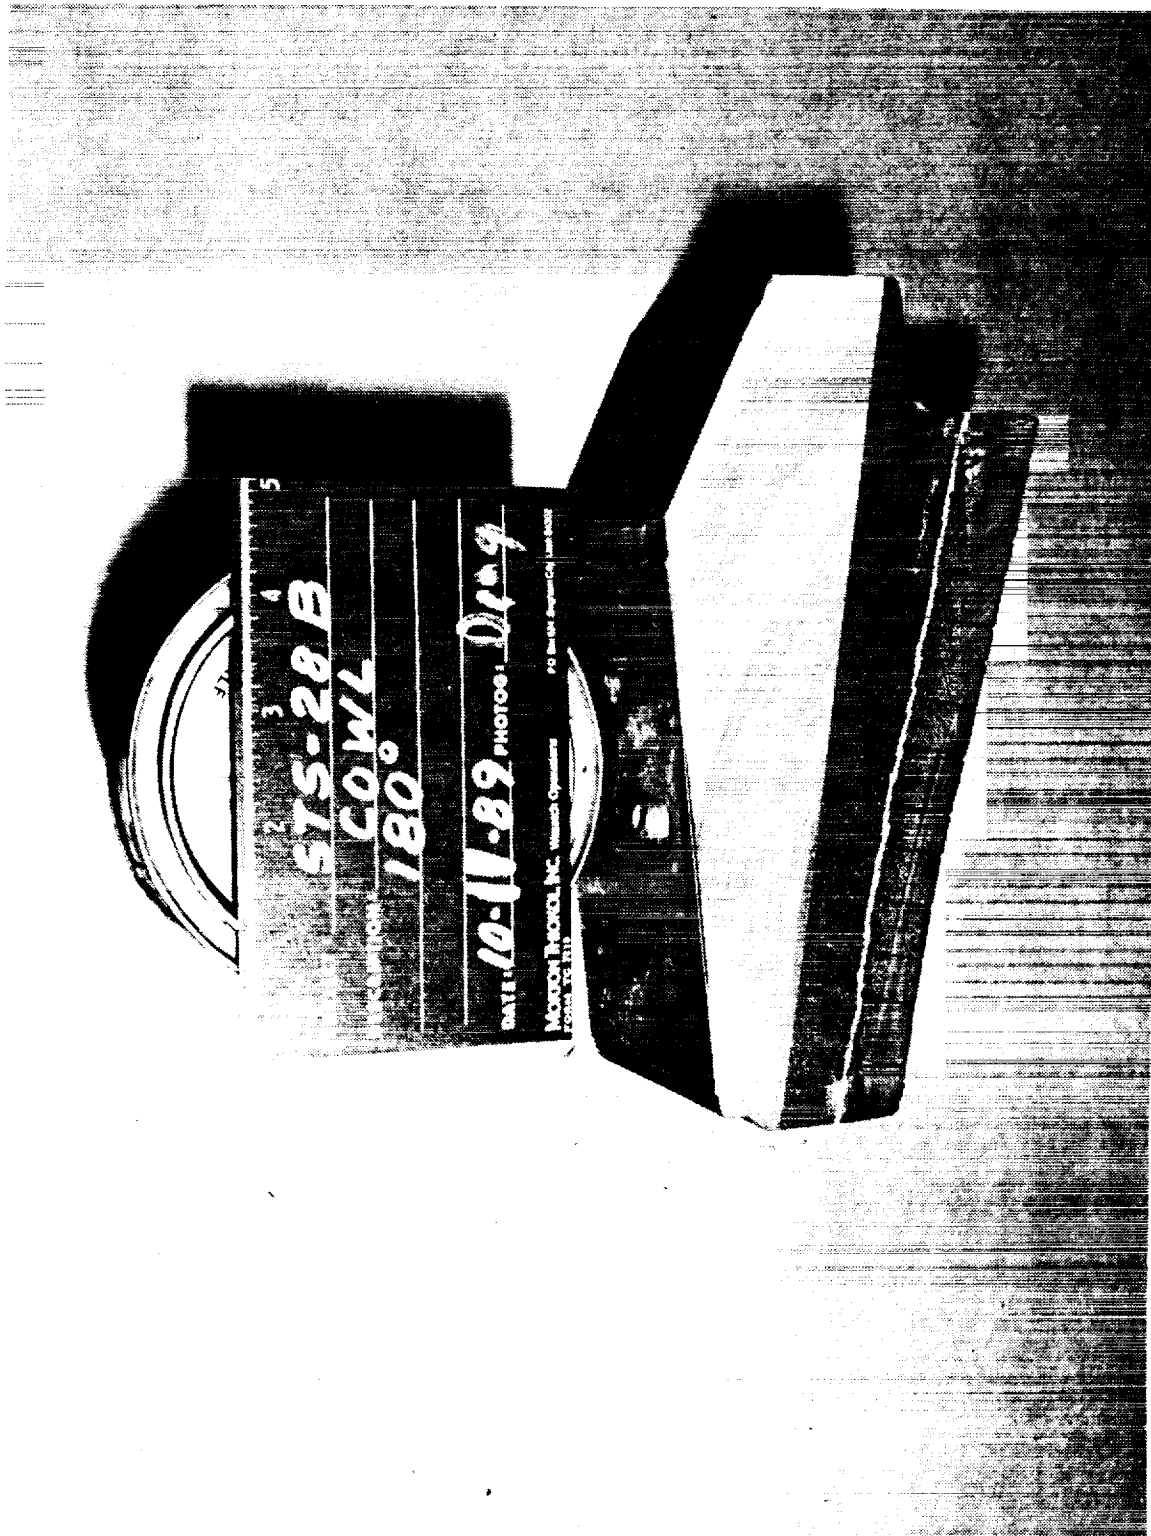
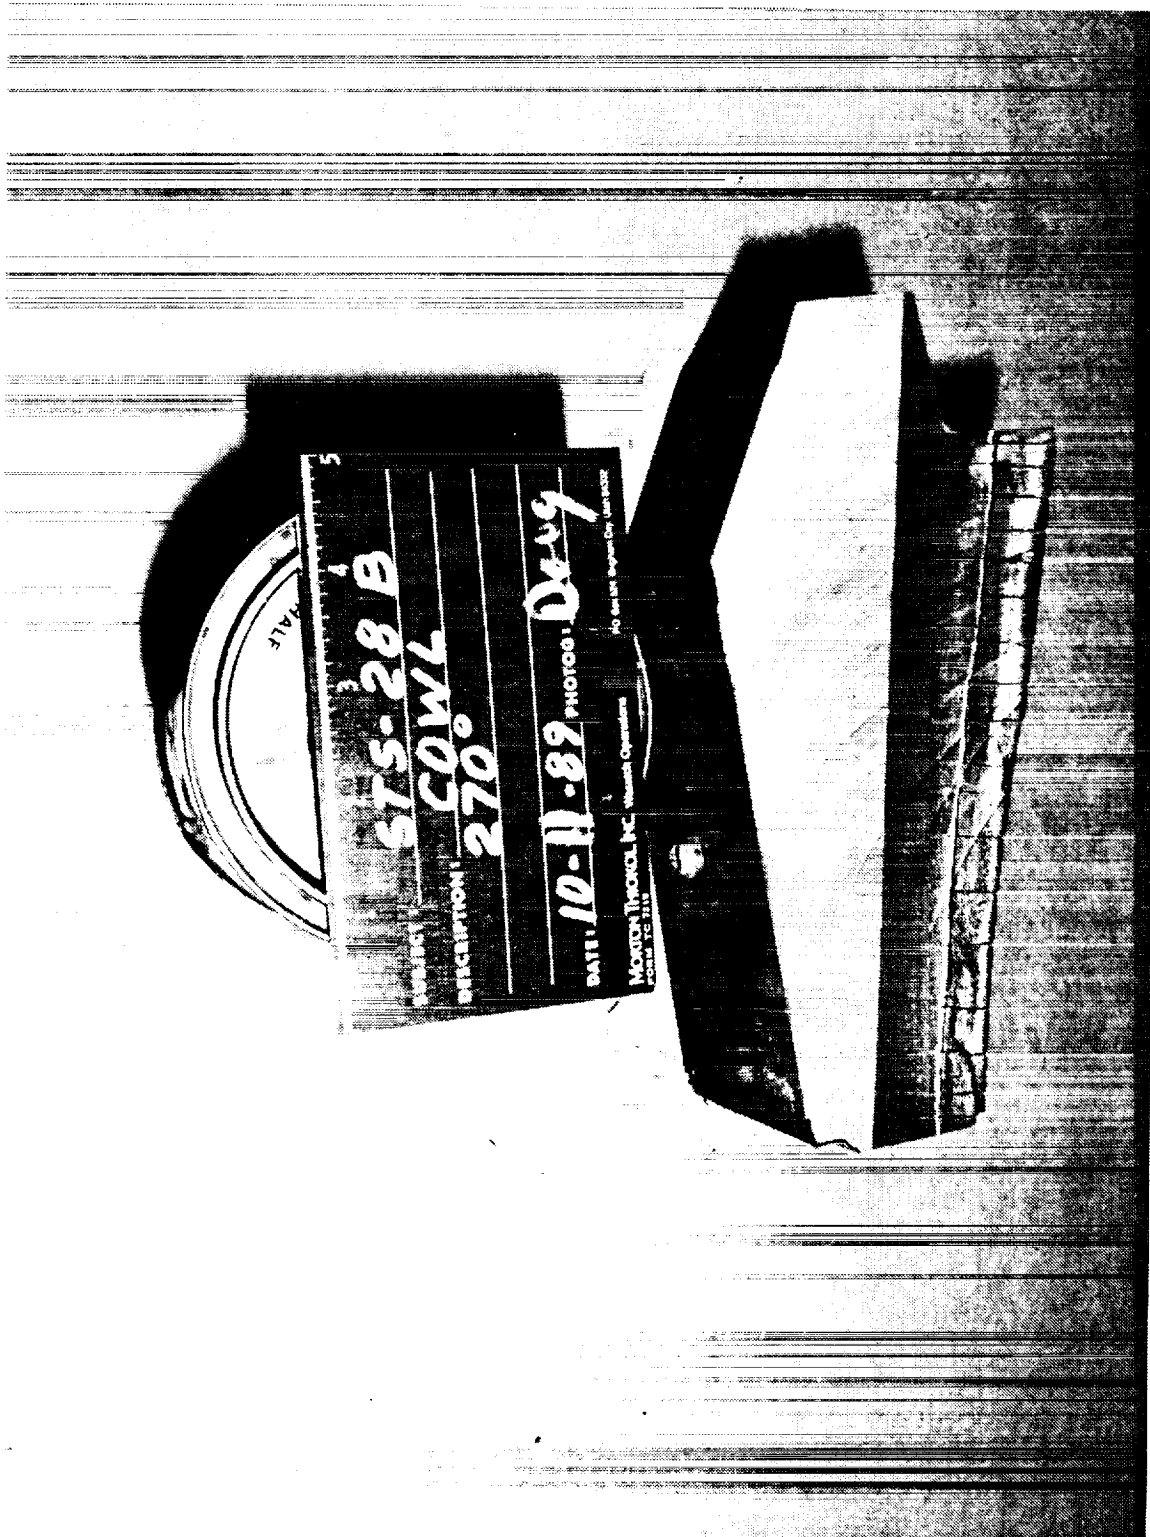
Photographs of the sectioned cowl ring are presented in Figures 120 through 123. Char and erosion analysis of the sections is presented in Table 14 (Stations 0 through 7). All margins of safety were positive, with a minimum of 0.22 occurring at station 2 (270 degrees).
